6. AUTHOR(S) D. J. Chang and H. A. Katzman		5d. PROJECT NUMBER		
		5e. TASK NUMBER		
		5f. WORK UNIT NUMBER		
7. PERFORMING ORGANIZATION NAME(S) AND ADDRESS(ES) The Aerospace Corporation Laboratory Operations El Segundo, CA 90245-4691		8. PERFORMING ORGANIZATION REPORT NUMBER TR-2003(1413)-1

Strength Degradation of Filament-Wound Graphite/Epoxy Tubes Due to Either Impact Damage or Fabrication Defects

1 August 2004

D. J. CHANG and H. A. KATZMAN
Space Materials Laboratory
Laboratory Operations

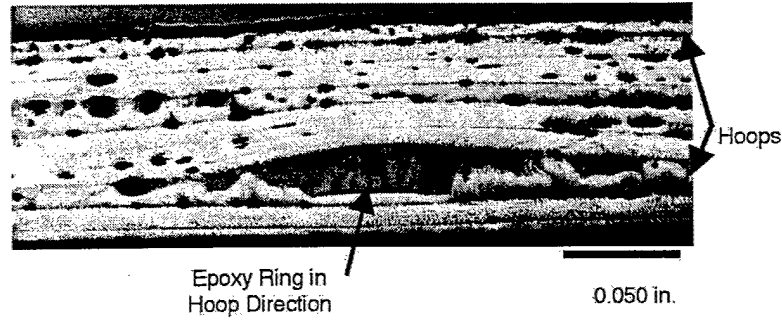
Figure 2. Cross section of minor helical-wrinkled tube (view of axial-radial plane).

The average burst pressure for the wrinkled tubes was 20.8 MPa (3022 psi). The helical wrinkle did not noticeably degrade the tube strength. One reason is that the strength of the tube is dominated by the hoop fibers. The composite stress in the hoop direction is twice the stress in the axial direction. However, the number of helical fibers is twice that of the hoop fibers. This results in an approximate

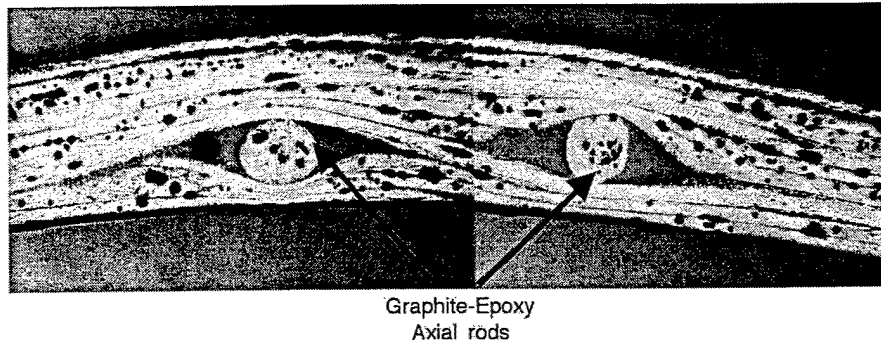
Figure 3. Cross section of hoop-wrinkled tube (view of radial-circumferential plane).

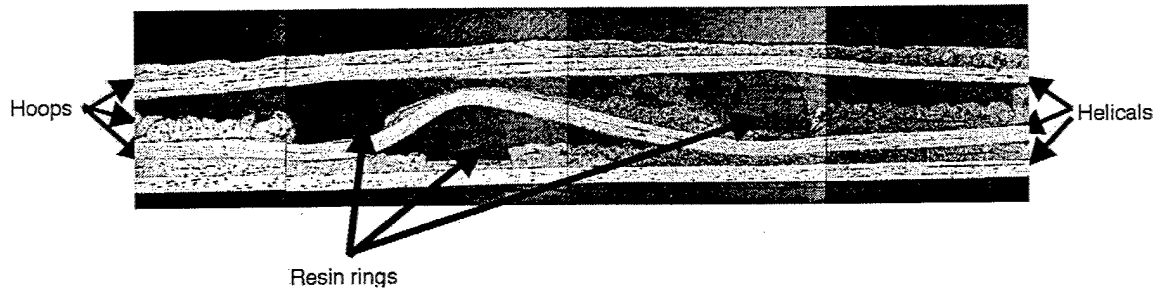
Figure 4. Cross section of severe helical-wrinkled tube (view of axial-radial plane).

A total of three wrinkled and two non-wrinkled specimen from this $(+15^\circ, -15^\circ, 90^\circ, 90^\circ)_3$ tube were tested. The average burst pressure of non-wrinkled specimens was 52.82 MPa (7658 psi), and the average burst pressure for wrinkled tubes was 48.82 MPa (7078 psi). This gives a 7.6% average strength reduction. The failure mode of the specimens in this test series is different from those in the previous three groups in which the failures were dominated by the hoop fibers with little influence from the helical fibers. This was true because there were half as many fibers in the hoop direction as

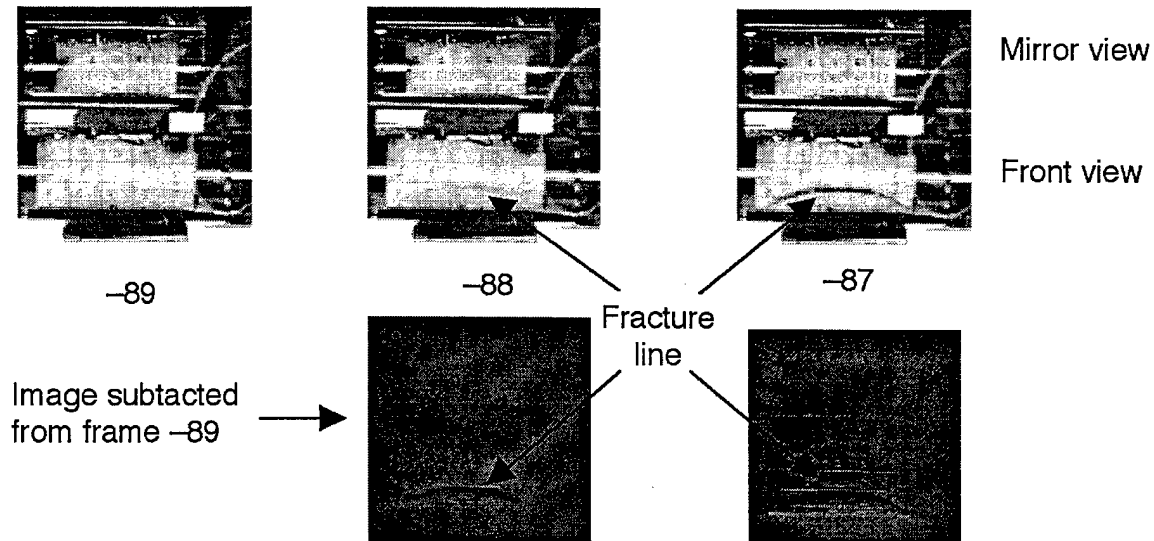
A total of nine specimens were fabricated and tested for this group. The tube specimens were typically 38.1 cm (15 in.) long. The average burst pressure was 19.7 MPa (2860 psi). There are typically two fracture modes for this series. One was a longitudinal mode with a crack running primarily in the axial direction. The second type of failure mode was a slanted crack at about 45° from the axial direction. Figures 8 and 9 depict the two types of failures as well as the subtracted frames from their respective reference frame at 74- μ s time intervals. In Figures 8 and 9, there are two tube images in

Figure 8. Longitudinal failure mode and subtracted images showing the failure sequence of specimen with no fabricated wrinkle (at 13500 frames/s).

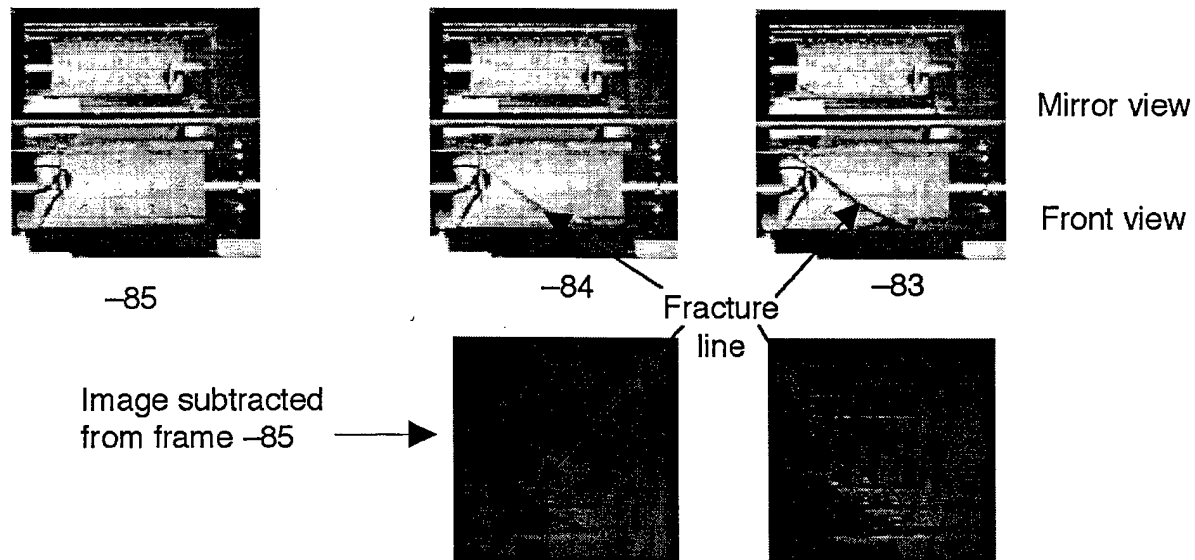
Figure 9. Slanted failure mode and subtracted images showing the failure sequence of specimen with no fabricated wrinkle (at 13500 frames/s).

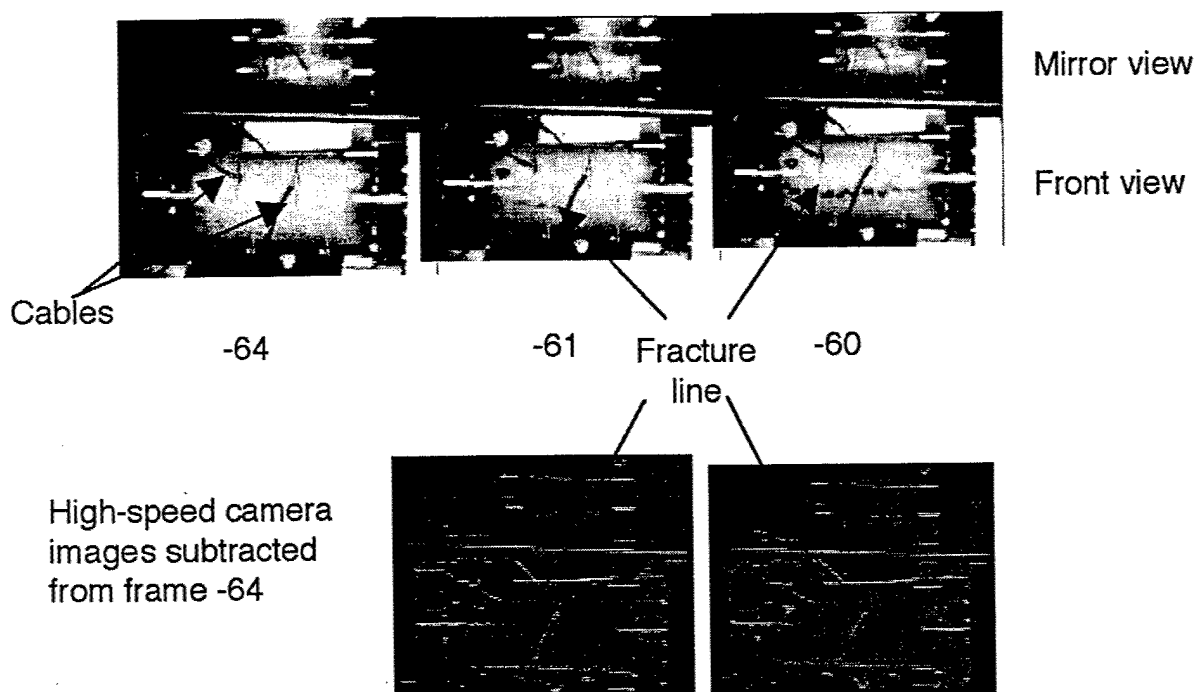
Hoop wrinkles significantly reduce the burst pressure. The fabricated hoop wrinkle was much more effective in degrading the strength than the helical wrinkle. The burst pressures range from 15.1 to 18.7 MPa (2195 to 2716 psi). The strength reduction averaged 14% and was as much as 23% of the pressure for un-wrinkled specimens. Figure 10 depicts a failure as well as the subtracted frames from the respective reference frame at 74- μ s time intervals. The fractures are all longitudinal.

Figure 10. Failure mode and subtracted images showing the failure sequence of specimen with a hoop wrinkle (at 13500 frames/s).

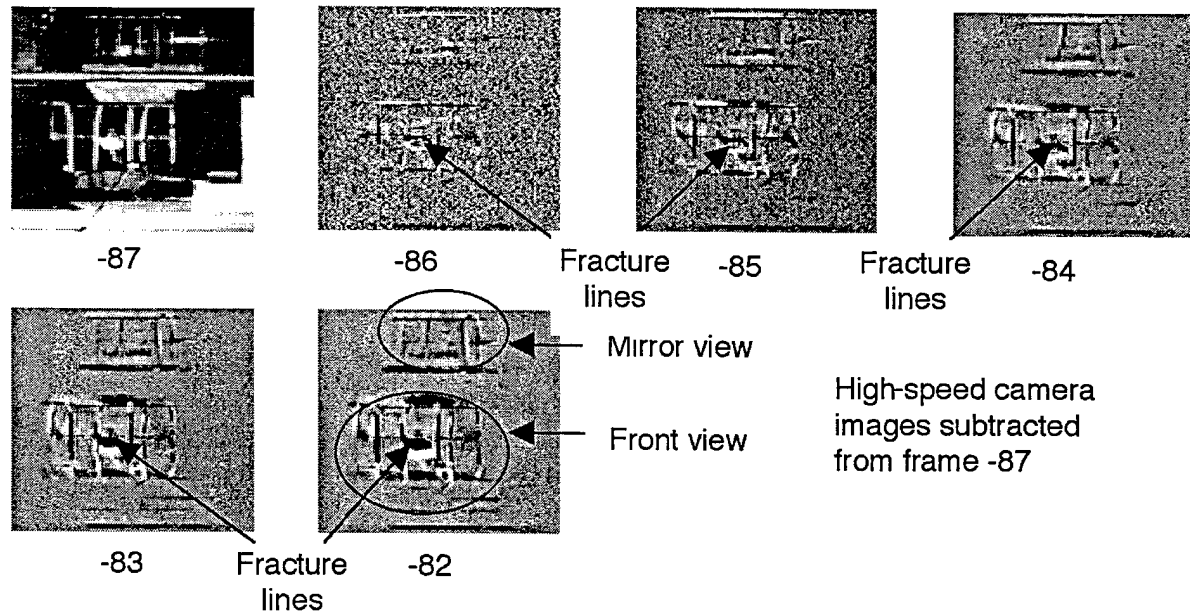
in the helical direction, while the hoop stress was twice the stress in the axial direction. For this series, the number of fibers is more or less balanced in both directions. The stress in the helical fibers became more significant at burst pressure, especially in the wrinkle region. Figures 11 through 13 depict the subtracted images for specimens IV-1, IV-2, and IV-5. Specimen IV-1 had no wrinkle, while specimens IV-2 and IV-5 were wrinkled. From these three figures, it can be seen that the failure for specimen IV-1 was hoop-fiber dominated, the failure of specimen IV-2 was mixed, and the failure of specimen IV-5 was helical-fiber dominated.

Figure 11. Failure mode and subtracted images showing the failure sequence of specimen IV-1 (at 13500 fps).

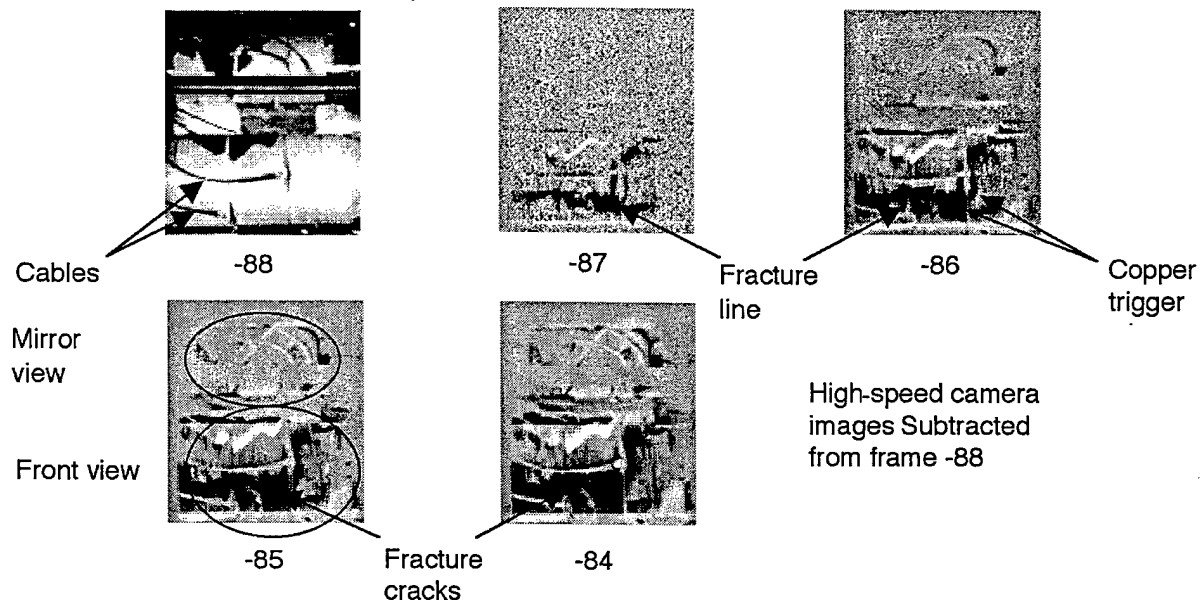
Figure 12. Failure mode and subtracted images showing the failure sequence of specimen IV-2 (at 13500 fps).

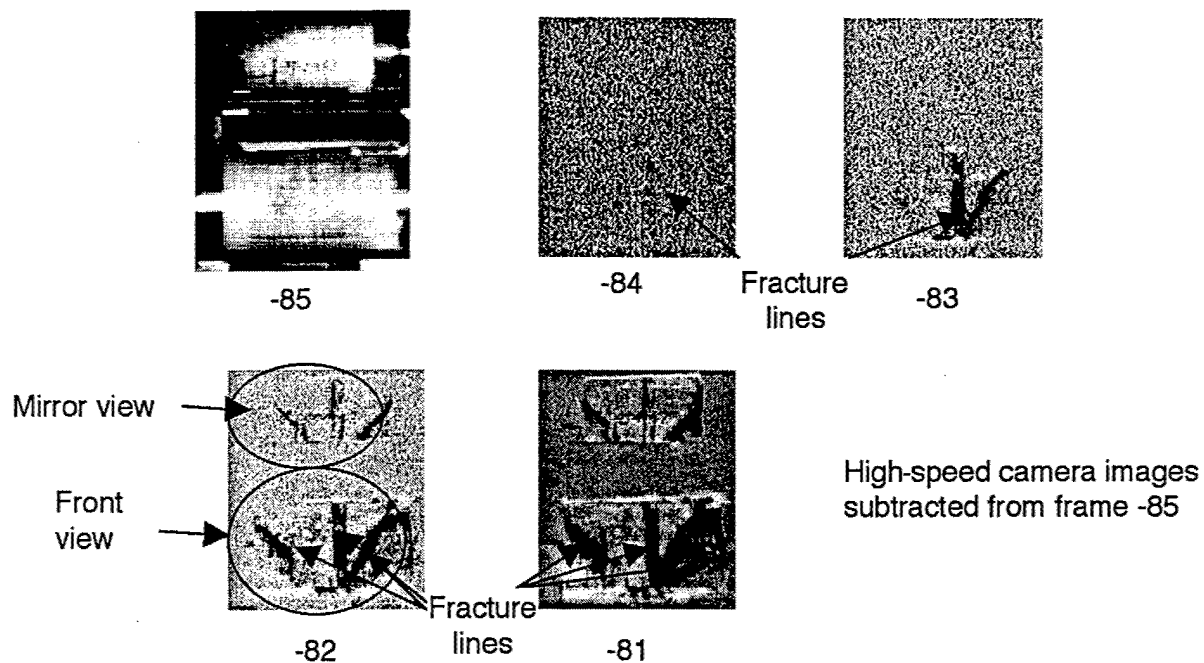
Figure 13. Failure mode and subtracted images showing the failure sequence of specimen IV-5 (at 13500 frames/s).
